Manhole Inspection Summary

Manhole # S47EE_023MH

Inspection Is Incomplete Rating: **3) Fair**

Insp Date: **7/21/08 10:03 AM**

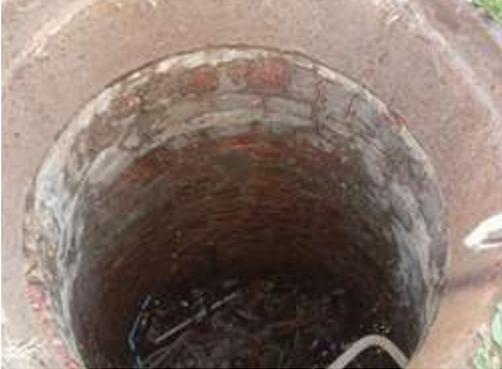
Defect 2

Frame Offset: **0.5** (in.) Condition: Sound Cracked **Leaks**

Frame leaks

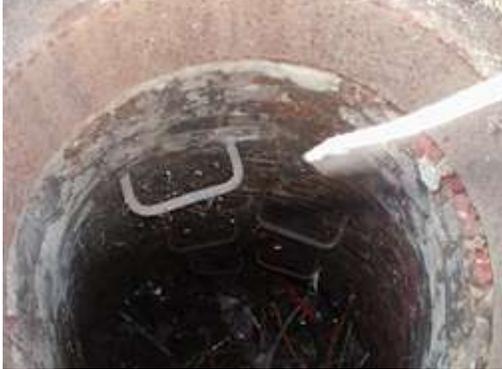
Defect 1

Infiltration: None Joint Cracks Mortar Roots **Wall**

Infiltration

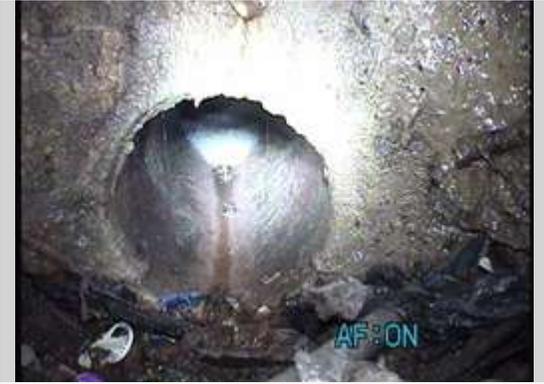
12 O'Clock Outflow

8 in. Circular Gravity Sewer
Pipe Out @ 12 O'Clock

Infiltration: **None** Pipe Seal Cond: **Sound**
